2018 norovirus outbreak linked to consumption of BC oysters: evaluation of environmental sewage sources find commercial vessels to be plausible source for contamination of the harvest area

Environmental Health Services

September 19, 2018

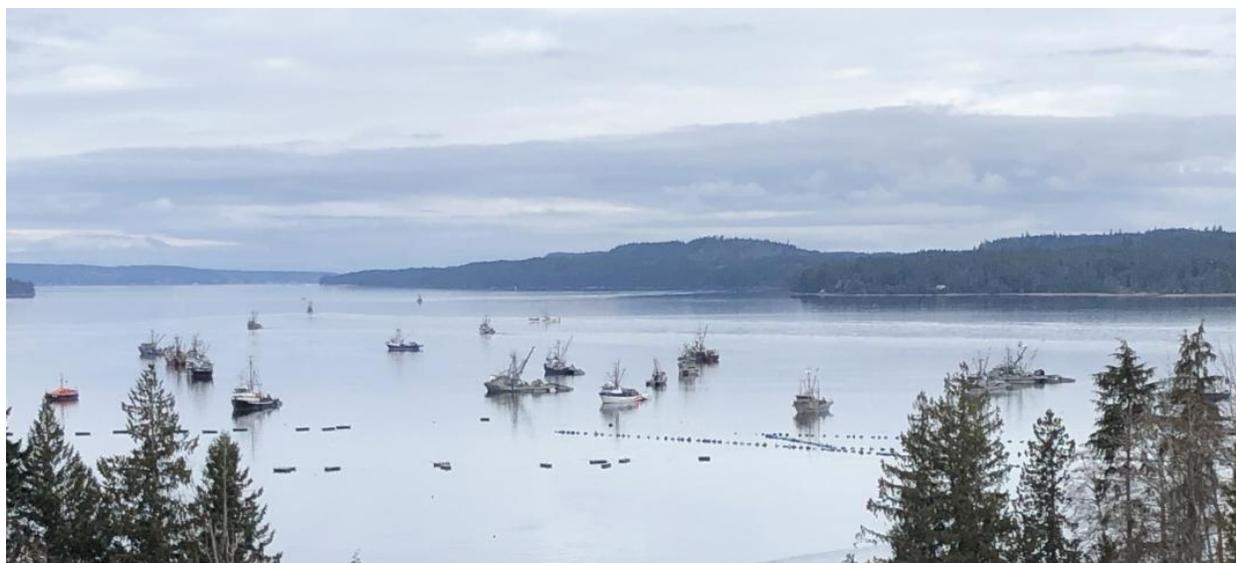
Commercial fishing vessels in proximity to oyster farms. Photo source: BC Shellfish Growers Association (March 6, 2018)

Vessels were observed anchoring directly adjacent to shellfish farm tenures, between February 25 to March 13, 2018. Photo documentation depict vessels within a few metres of active shellfish farms. Areas within Baynes Sound, from the shore of Vancouver Island to the shore of Denman Island range between 1.6 km to 4 km, with the distances reduced to less than 1 km if the shellfish farms are used as boundaries (refer to map Appendix 1).

According to Transport Canada regulations⁶, vessels are prohibited from discharging waste within three nautical miles or 5.5 km of shore (see Appendix 3). Within the Baynes Sound area, from the coastline of Denman Island to the coastline of Vancouver Island, there is no area 11km in width, therefore no sewage discharge from vessel traffic is allowable within Baynes Sound, unless on-board sewage treatment occurs.

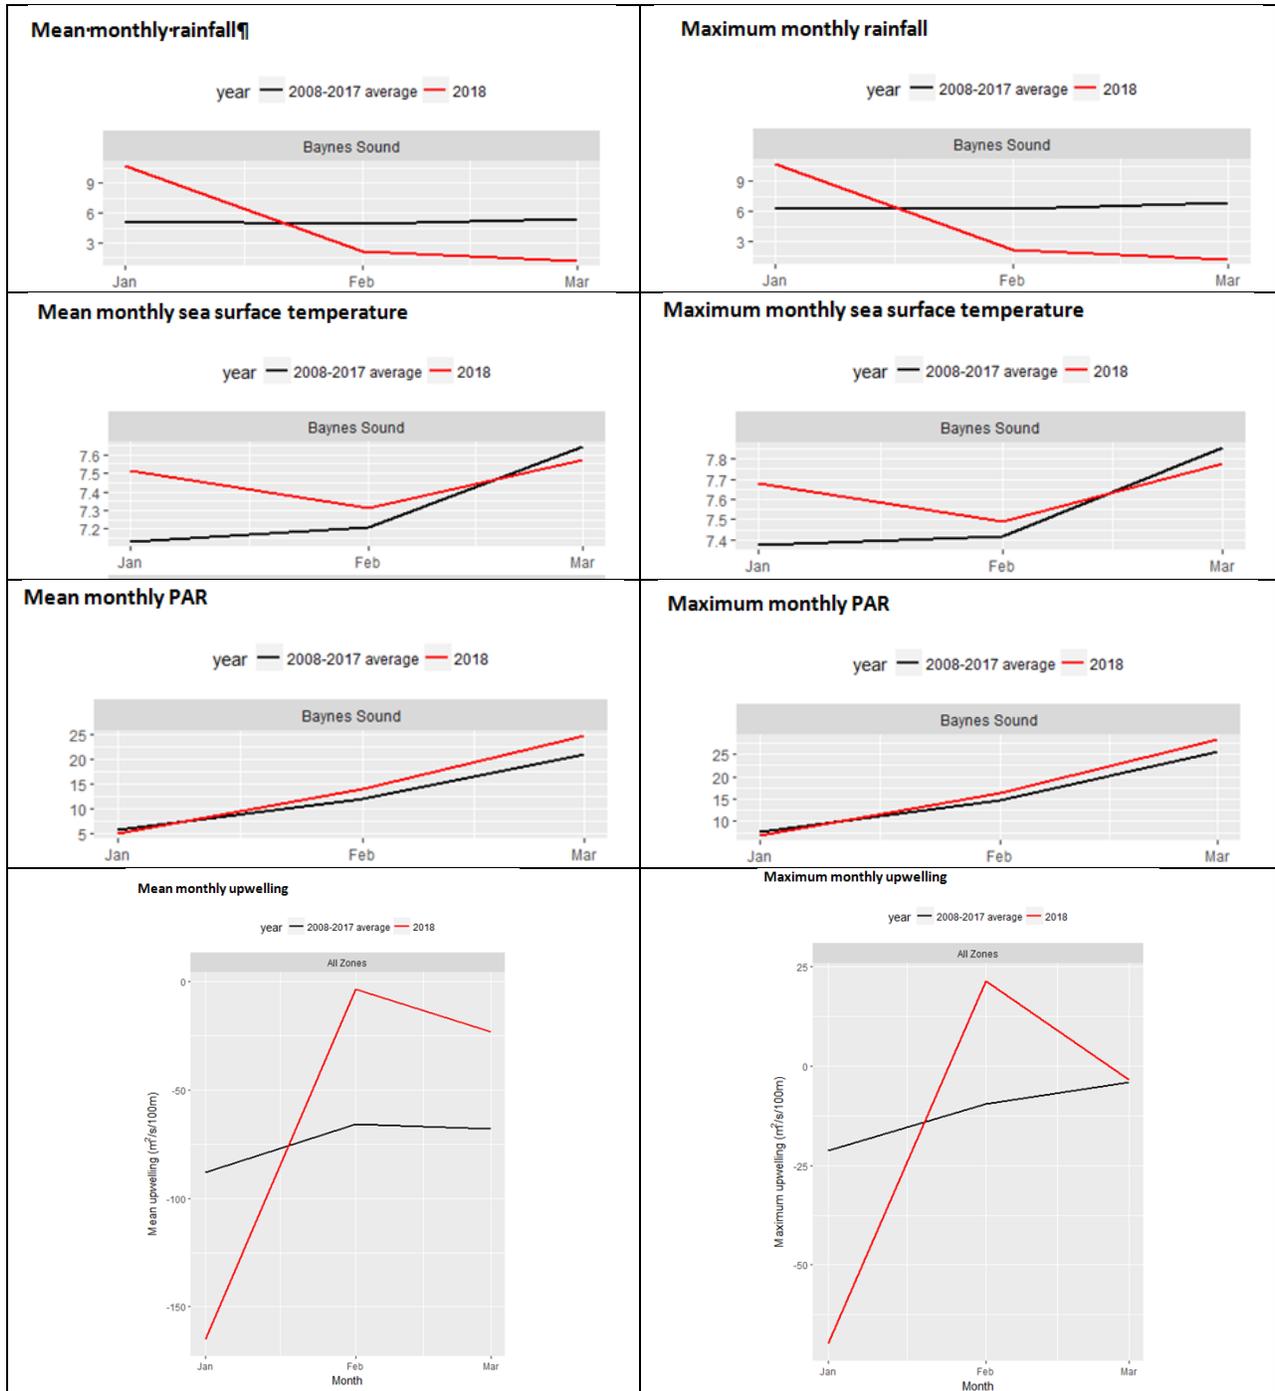
Appendix 2. Environmental conditions in Baynes Sound, Jan to Mar 2018

Environmental conditions of concern associated with norovirus spread and persistence in the environment were also examined in the months leading up to the outbreak. Precipitation, sea surface temperature, sunlight (photosynthetically active radiation or PAR), and upwelling are shown in Appendix 2.

One of the four environmental conditions (precipitation) was present that may be predictive for norovirus and oyster contamination. However, the other three environmental conditions were either near seasonal norms (sea surface temperature and sunlight), and not notable for prolonged survival of norovirus in the environment, or in the case of downwelling, shown to be weaker than normal and less likely to force surface water downwards. The interpretation of environmental parameters with respect to affecting spread and survival of norovirus has not been rigorously assessed. When evaluating the parameters shown in Appendix 2, it appears that not all environmental conditions were present. While moderate levels of rain occurred in early January, no illnesses were linked to oyster consumption until greater than 10 weeks later, suggestive that this factor, while present, was not able, possibly in the absence of the other factors, to spread norovirus in the environment to oyster farms. The time period following a rainfall to when norovirus oyster bed contamination will occur varies, periods as short as a few hours have been reported. During 2016-17, when heavy near record rainfall occurred in November 2016, the first wave of illnesses began within two weeks in November. This time-frame is consistent with harvesting to consumption (oysters may be harvested, processed and sold in as few as three days) and illness reporting delays (often one or more weeks). Illness clusters were also reported in December, in January

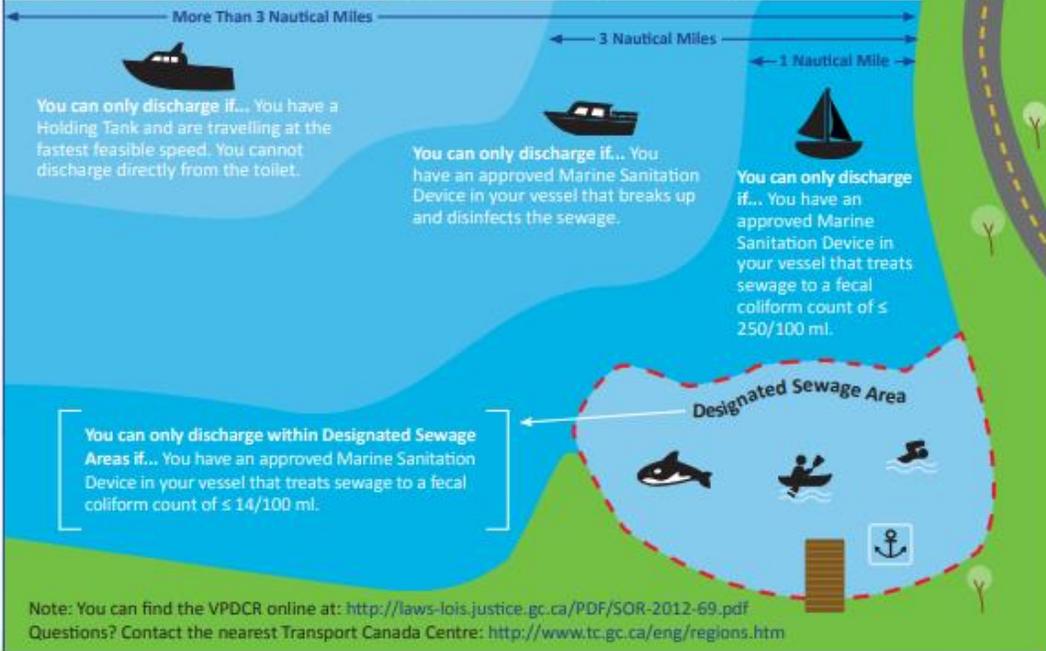
Consider your distance from shore:
Important Note: You CAN NEVER discharge sewage within inland waters (rivers and lakes)

More Than 3 Nautical Miles: You can only discharge if... You have a Holding Tank and are travelling at the fastest feasible speed. You cannot discharge directly from the toilet.

3 Nautical Miles: You can only discharge if... You have an approved Marine Sanitation Device in your vessel that breaks up and disinfects the sewage.

1 Nautical Mile: You can only discharge if... You have an approved Marine Sanitation Device in your vessel that treats sewage to a fecal coliform count of ≤ 250/100 ml.

Designated Sewage Area: You can only discharge within Designated Sewage Areas if... You have an approved Marine Sanitation Device in your vessel that treats sewage to a fecal coliform count of ≤ 14/100 ml.
